# GRAVEL RECLAMATION

## PETROLEUM BASED

# STABILIZER RECLAMATION

# COLD-MIX RECLAMATION

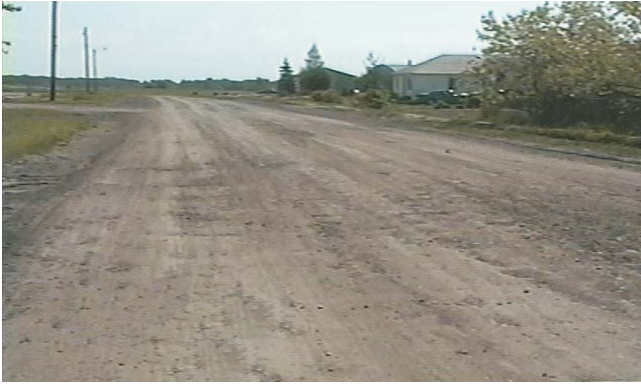
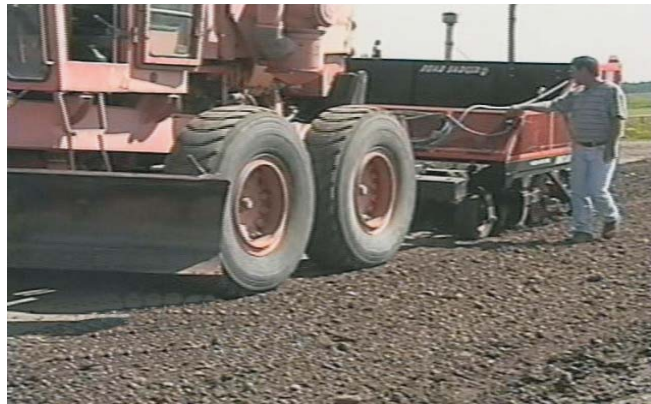
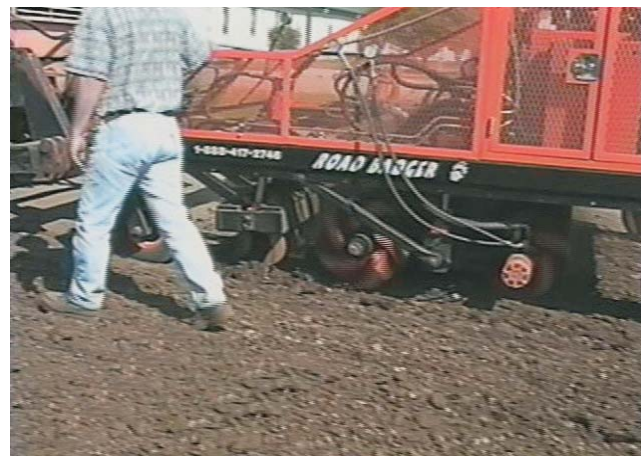
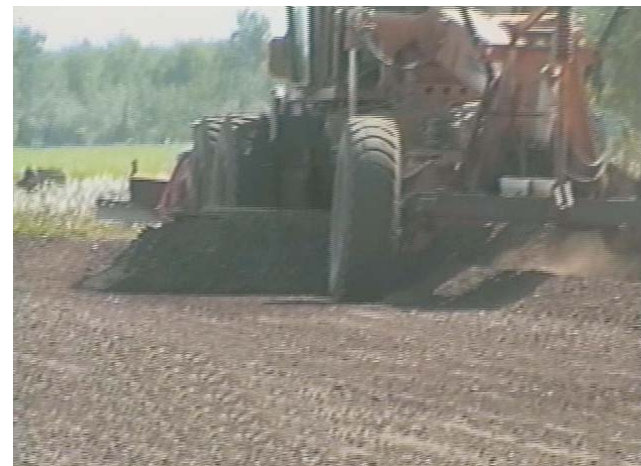
These photos show a 400m graveled town road that has developed extensive potholes, washboard and has little visible gravel. This road had been scheduled for re-construction, including re-graveling, by the County.

Instead of resorting to the grader's ripper bar, the Road Badger utilized its infinite depth control system and retrieved the road surface material at a pre-determined depth of 2 inches in approximately 1/2 hour.

The Road Badger reclaimed ample aggregate material to re-grade the road as well as eliminating all road defects without disturbing the road base.

Due to the hardness of the road surface a grader would be unable to blade the road and would therefore have to break up the surface with a grader's ripper bar (which has no depth control and often breaks into and disturbs the clay base). This would be followed by sub-base re-compaction then re-graveling and re-shaping as per the County's current methods.

By using the Road Badger the County was able to avoid base contamination, sub-base re-compaction and re-graveling; saving a large amount of the tax payer's money on aggregate and equipment operation costs.

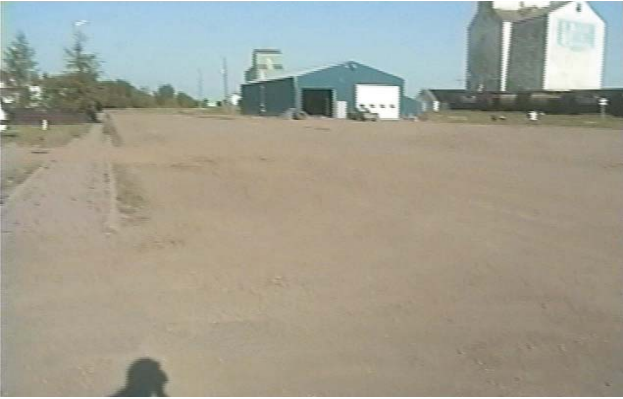
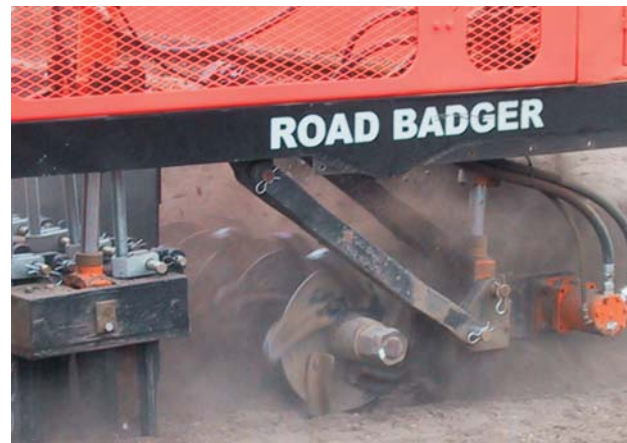
These photos show a petroleum based stabilized town road that has developed potholes, ruts and washboard.

The County's current method of road maintenance would be to scarify the road surface with a grader's ripper bar, which, due to its lack in depth control could cause contamination to the existing aggregate and soil stabilizer with sub-grade material. Then re-surface with the costly addition of extra aggregate material and stabilization product.

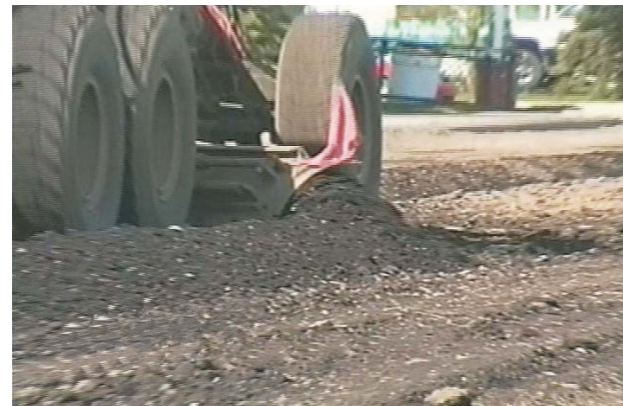
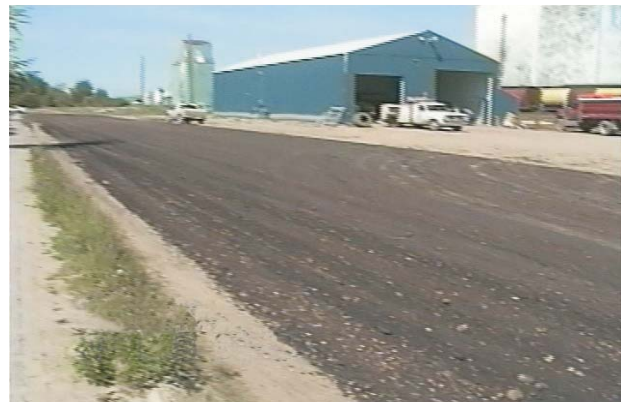
The Road Badger broke-up, retrieved and re-mixed the existing road surface material, eliminating the road defects while preserving the integrity of the road base.

This 1200 meter road was in poor condition but after 1 hour of using the Road Badger and without the addition of extra surface material, the town had a smooth driving surface at a substantial savings to the taxpayers.

Due to the results of the Road Badger, the county decided there was no need to add any materials.

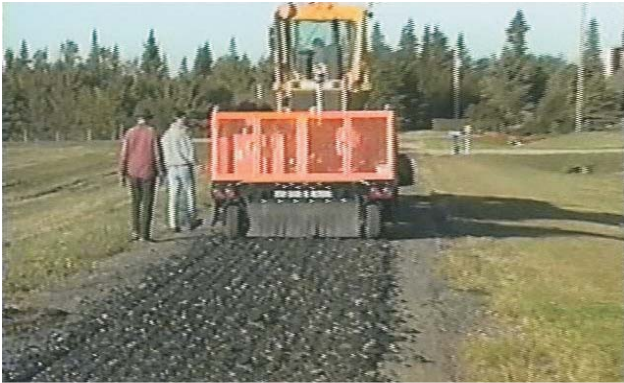
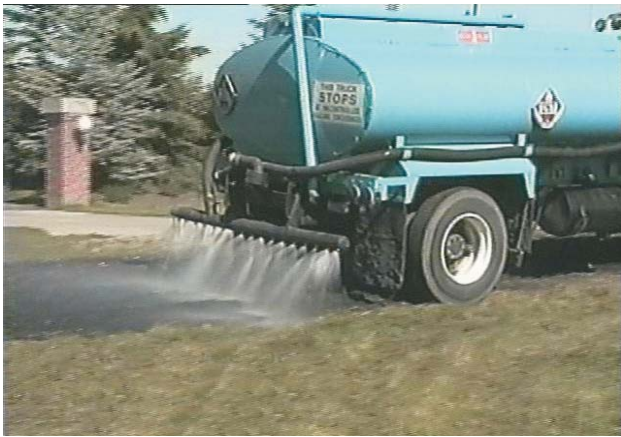
The photos show the Road Badger rejuvenating an existing cold-mix asphalt road in a local subdivision.

The road was scheduled to be scarified and windrowed prior to 80 cubic yards of aggregate and 7,200 litres of oil being added in order to restore the road to a smooth driving surface.

Instead, the Road Badger scarified the road surface at a pre-determined depth of 3 inches, reclaiming and re-mixing the existing material without disturbing the subgrade.

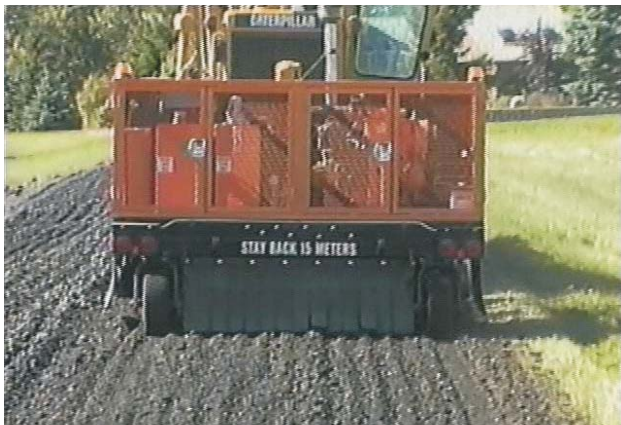
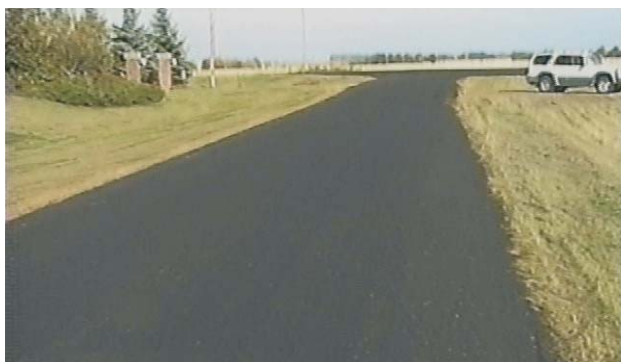
Instead, the County added a stabilizer and utilized the Road Badger to mix the product into the road surface material. The Road Badger uniformly mixed the material and product together in-place and the road was completed by profiling and then compaction.

The Road Badger was able to recover sufficient material to re-grade the road and the County decided that the additional aggregate and oil were no longer required.

The ability of the Road Badger to effectively and efficiently reclaim the road surface material and mix in a stabilization product provided the County and its constituents with great cost savings.

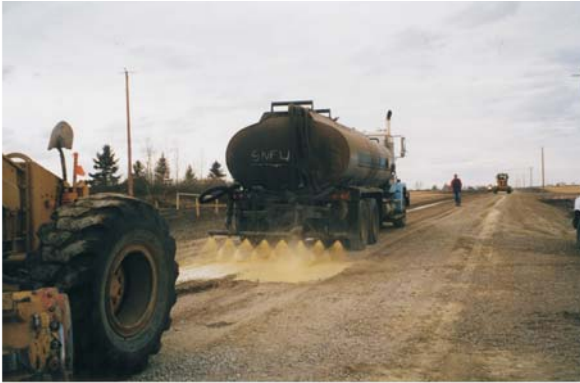
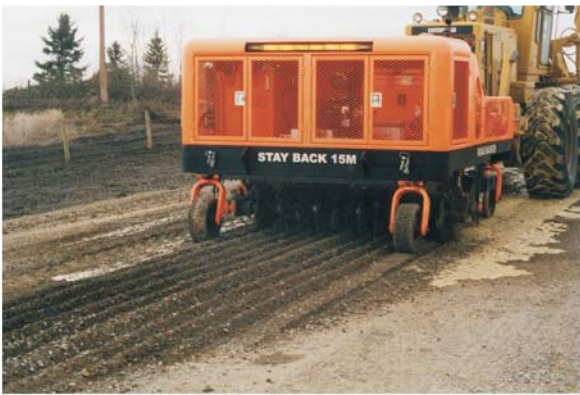
These photos show a newly re-constructed road base with a fresh gravel lift of between 4-6 inches deep and approximately 14 feet wide, intended to be stabilized with a lignum based stabilization product.

After application of the stabilization product, the Road Badger was used to effectively and efficiently mix the product into the gravel lift in a single pass.

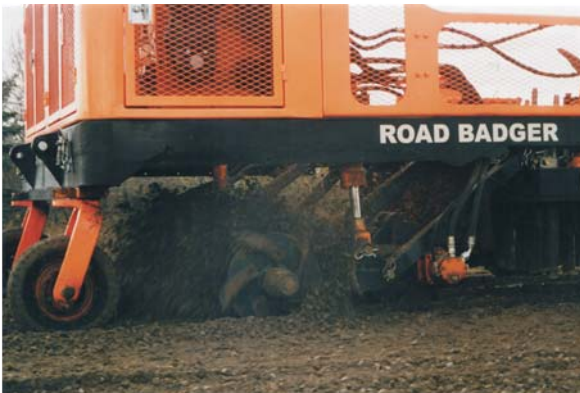
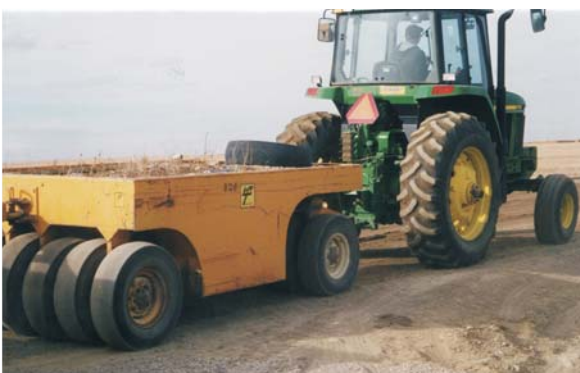
Following mixing, the grader unhooked the Road Badger and began profiling the road surface, tight blading to shape the crown for appropriate drainage. Compaction with a dual wobbly system completed the project.

The stabilization process was complete in minimal time and with little vehicle disruption due to the fact that the Road Badger is able to uniformly mix the product in-place.

The Road Badger allows applicators the opportunity to mix stabilization products into the road surface in less time and with an increased efficiency then conventional blade mixing and at a much lower cost then a reclaimer.
